REMR TECHNICAL NOTE CS-MR-8.2

CASE HISTORY OF LOCK REHABILITATION: BRANDON ROAD LOCK, ILLINOIS WATERWAY

PROJECT: Brandon Road Lock is located on the Des Plaines River about 3 miles south of Joliet, Illinois. The lock is at mile 286 on the Illinois Waterway. Constructed in 1928, the 110-ft-wide by 600-ft-long lock was shut down on 5 July 1984 for rehabilitation.

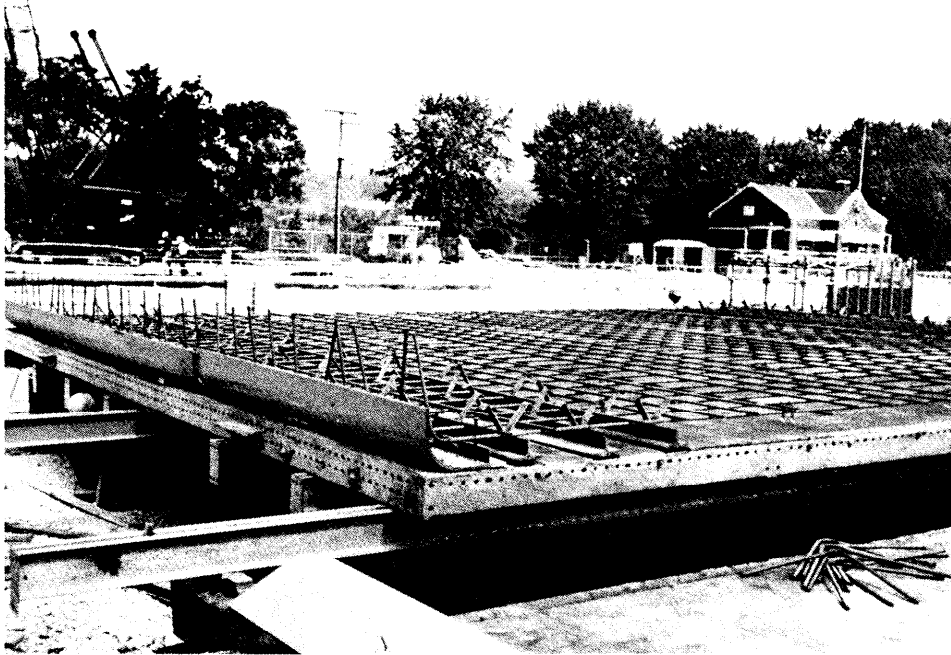
Wall armor and concrete reinforcement in place on form

Wall and armor concrete reinforcement, No. 6 bars on 12-in. centers each way, were installed on the concrete forms prior to placing the form on the lock wall. A truss system was used to span the lock chamber, thus supporting forms on opposing monoliths of each wall simultaneously.

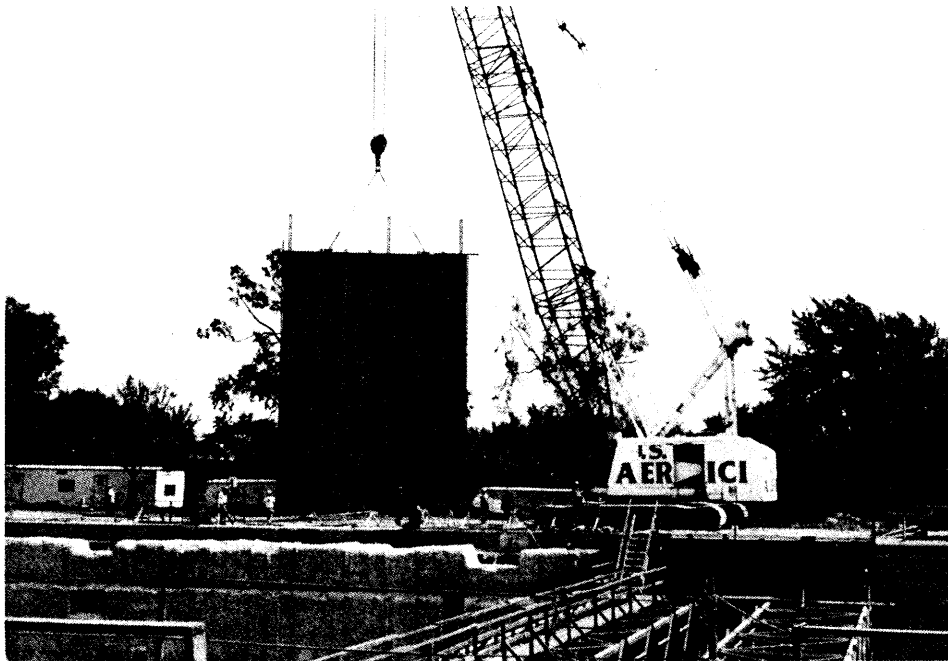
Concrete forming being placed in position on lock wall

Replacement concrete was placed in a single lift for each 30-ft-wide monolith. This required approximately 85 and 100 cu yd of concrete for landside and riverside monoliths, respectively. Concrete for resurfacing the vertical walls was discharged into hoppers with elephant trunks of varying lengths. Concrete for the 2-ft cap on the top of the lock walls was discharged directly into the form. Internal vibrators were used to consolidate the fresh concrete. Due to the limited space and the depth, there was some difficulty in vibrating the concrete near the bottom of the lift in a few monoliths, which resulted in some honeycombed areas. The perimeter of these isolated areas was saw cut and the concrete chipped to a minimum depth of 2 in. prior to repair.
